## Historic Move of Historic Structure

**IASM members partner to relocate historic railway structure in Sydney**

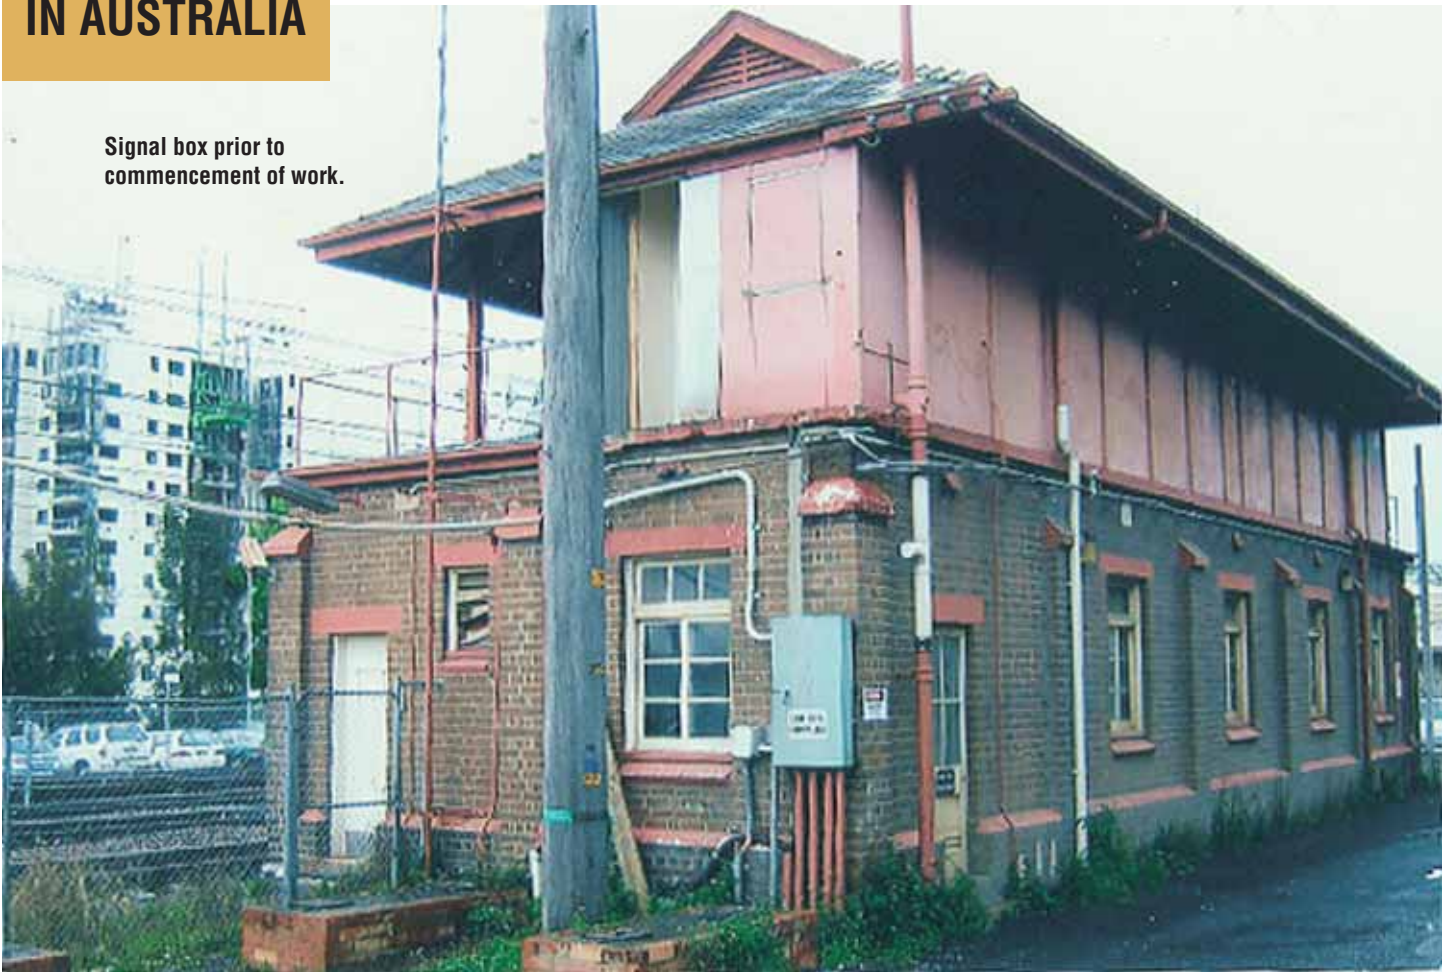
Signal box prior to commencement of work.

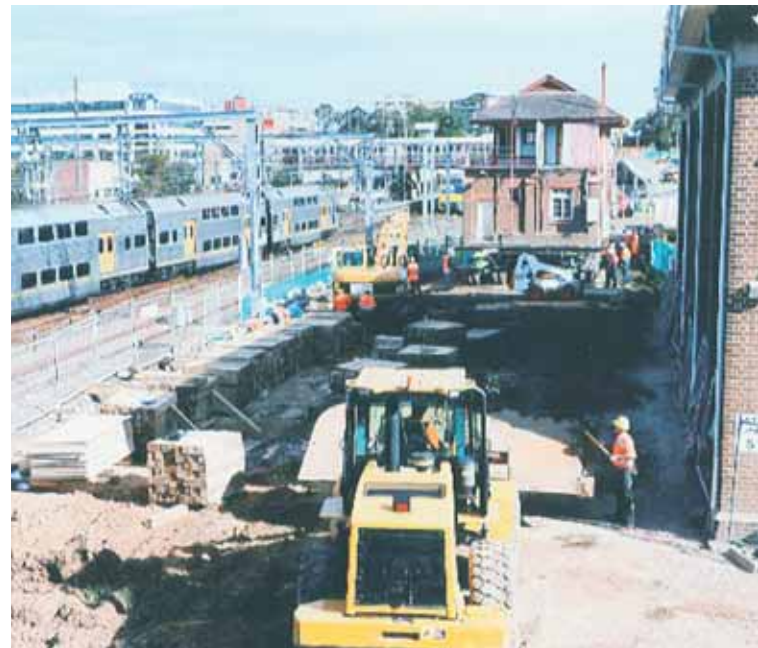
During relocation.

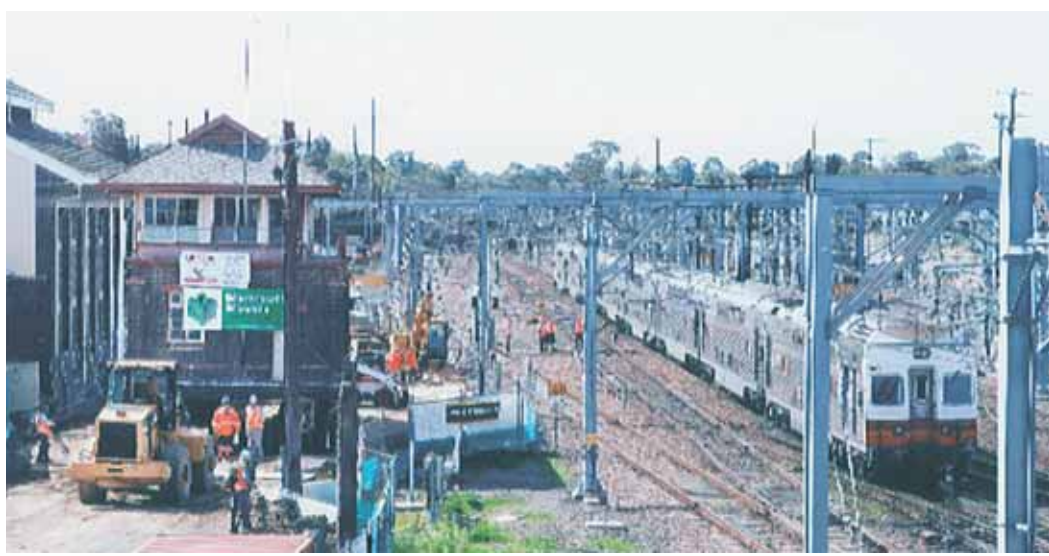
Halfway along its relocation path showing adjacent rail lines.

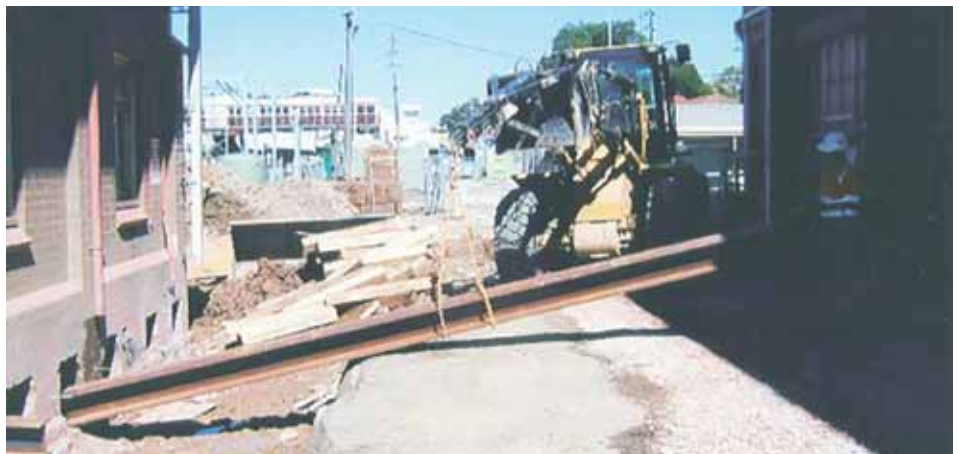
Installation of cross beams showing excavation limit due to underground cables.

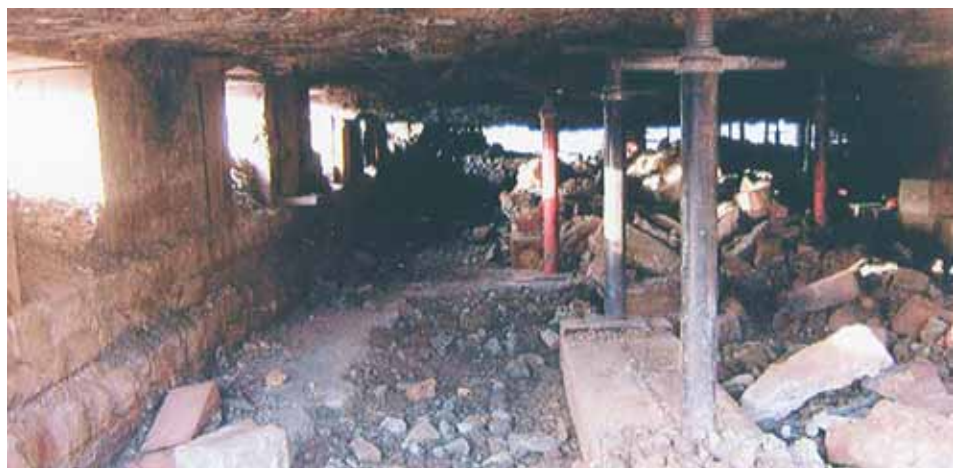
Partition wall footers and windows cut in perimeter wall.
