## Yearlong job earned Nickel Bros. reputation for moving and preserving historic structures

By JACK E. BRYMER, SR., Contributing Editor

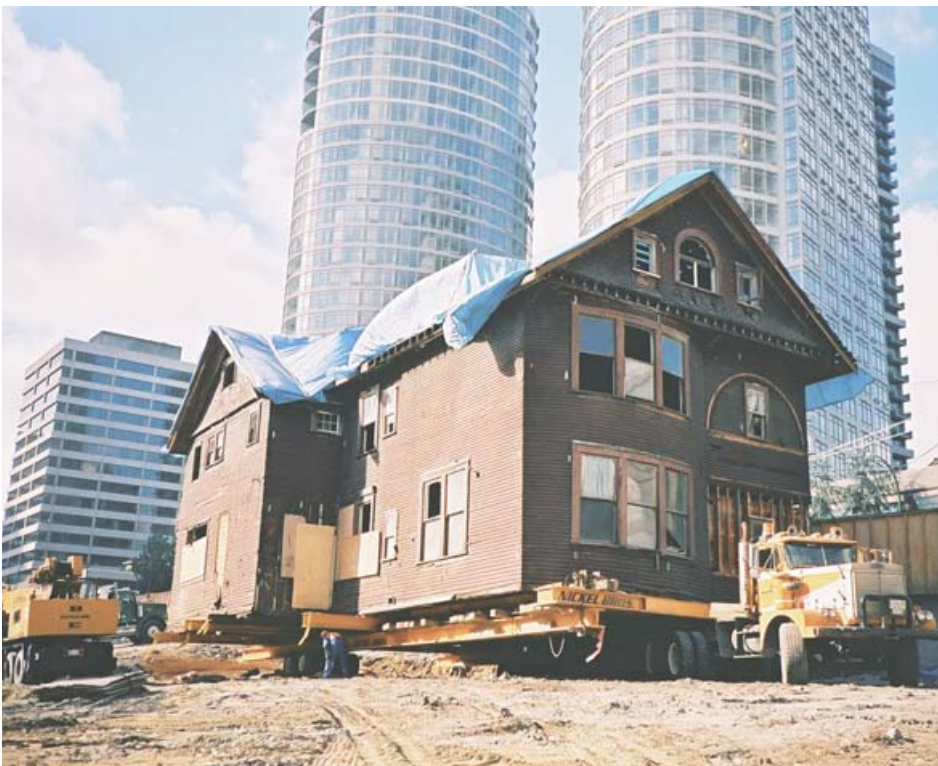
(Above) The Abbott House as it looked prior to the restoration/relocation process. A stucco finish had been applied to the exterior of the building. Before Nickel Bros. House Moving, Ltd., began work with the customer, Bell Construction stripped and cleaned out the building, removed fireplaces, removed gypoc and stucco, removed rock work from the building, removed the furnace and hot water heater from the basement and removed non-bearing walls and stairs in the basement.

Bell Construction was required to excavate around the building and clear a parking lot east of the building. Nickel Bros. installed crossbeams and elevated the structure 3–4 feet in order for Bell Construction to remove the perimeter foundation. Nickel Bros. then installed the main beams and wheels under the building and relocated the structure to a parking lot, rotating the building 90 degrees to clear the site. A requirement of the project was that the building could never leave the site. This photo shows the building being returned to the original location for placement on piers and caisson built by Bell Construction.

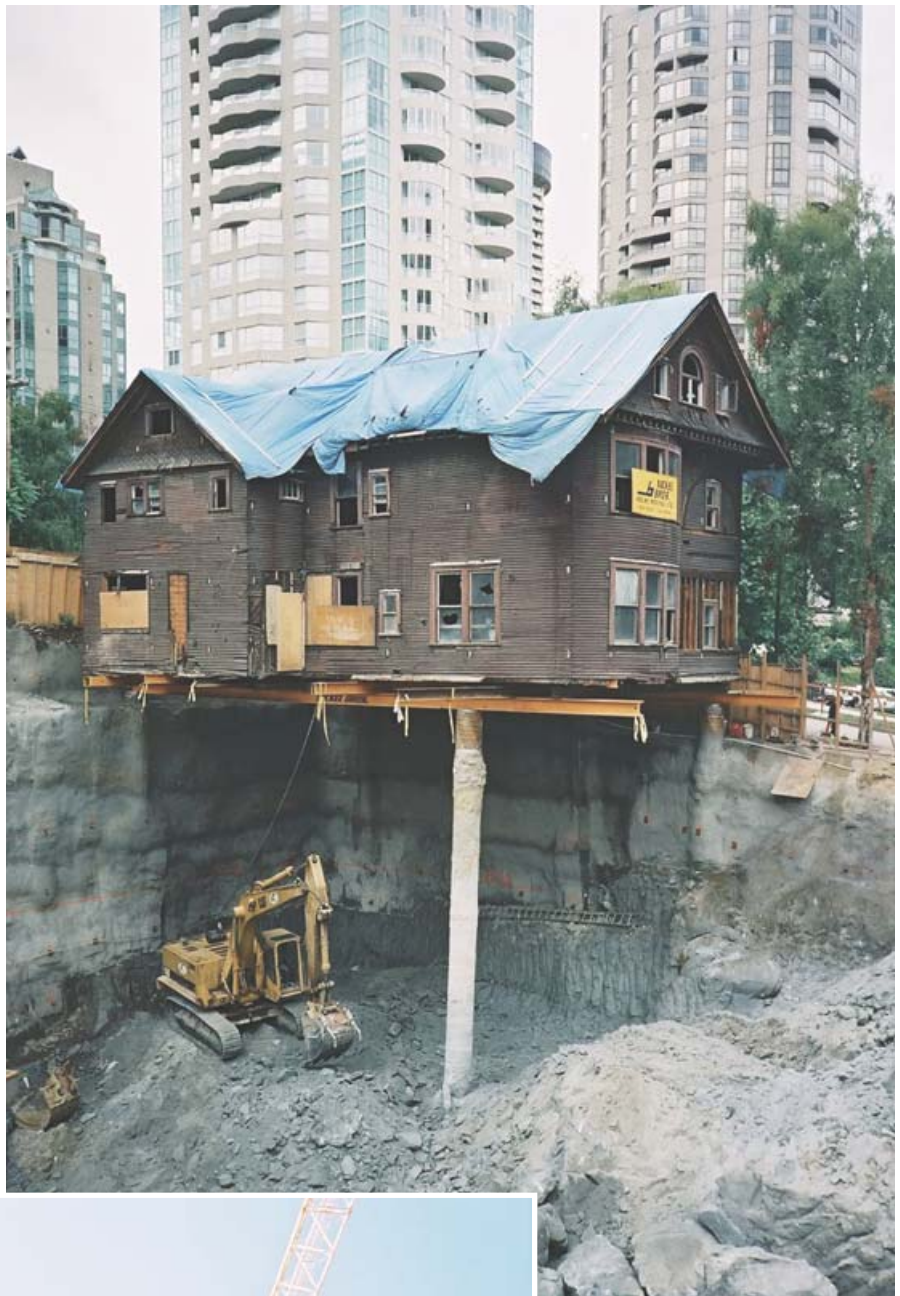
**Building is in place on piers and caisson.**

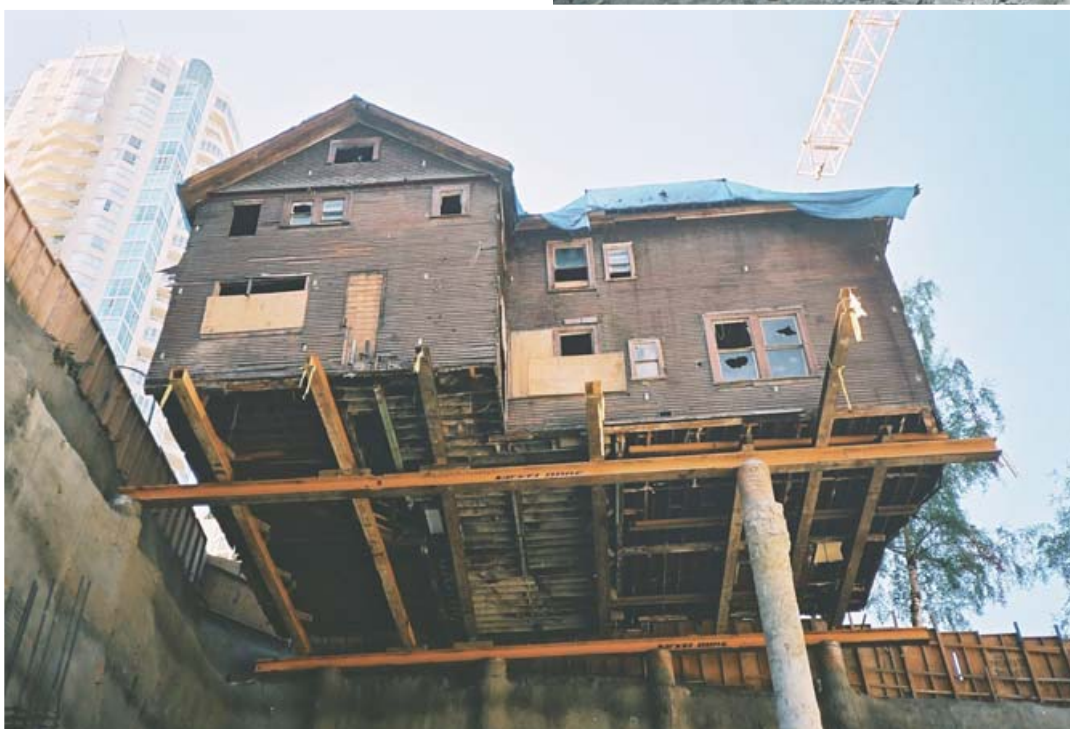
**Building situated at the corner of the project with cross and main beams in full view.**
